Sudden downshift mechanism

**NHTSA Sudden Down Shift Investigation
BGFA-1018720 Low Temperature**

**BGFA-1018818 Sudden Down Shift Investigation
Low Temperature Mode**

**B7WA-8014113 Sudden Down Shift Investigation
Low Temperature Mode**

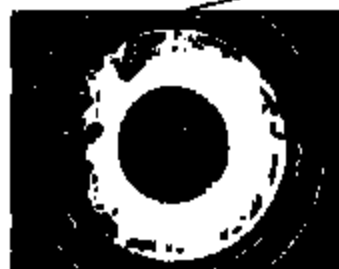
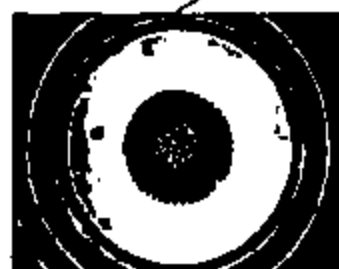
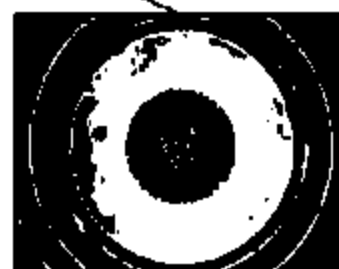
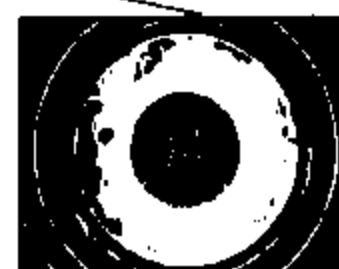
SAT LINEAR SOLENOIDS

*Disassembly revealed no contamination - NTF -

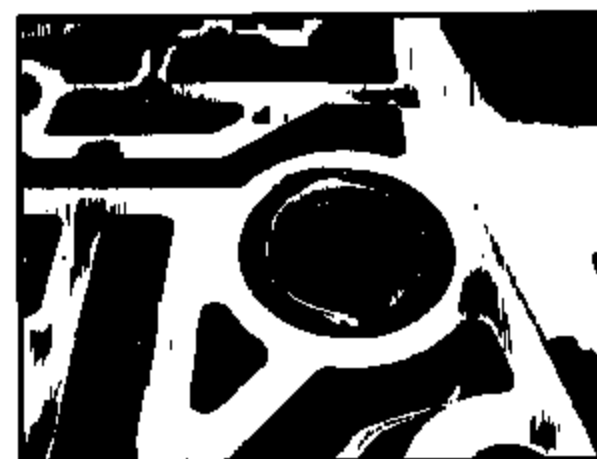
MVB FILTER SCREEN

Note: Component failure similar in three missions analyzed.
